engineers | scientists | innovators

# LAKE PETIT DAM

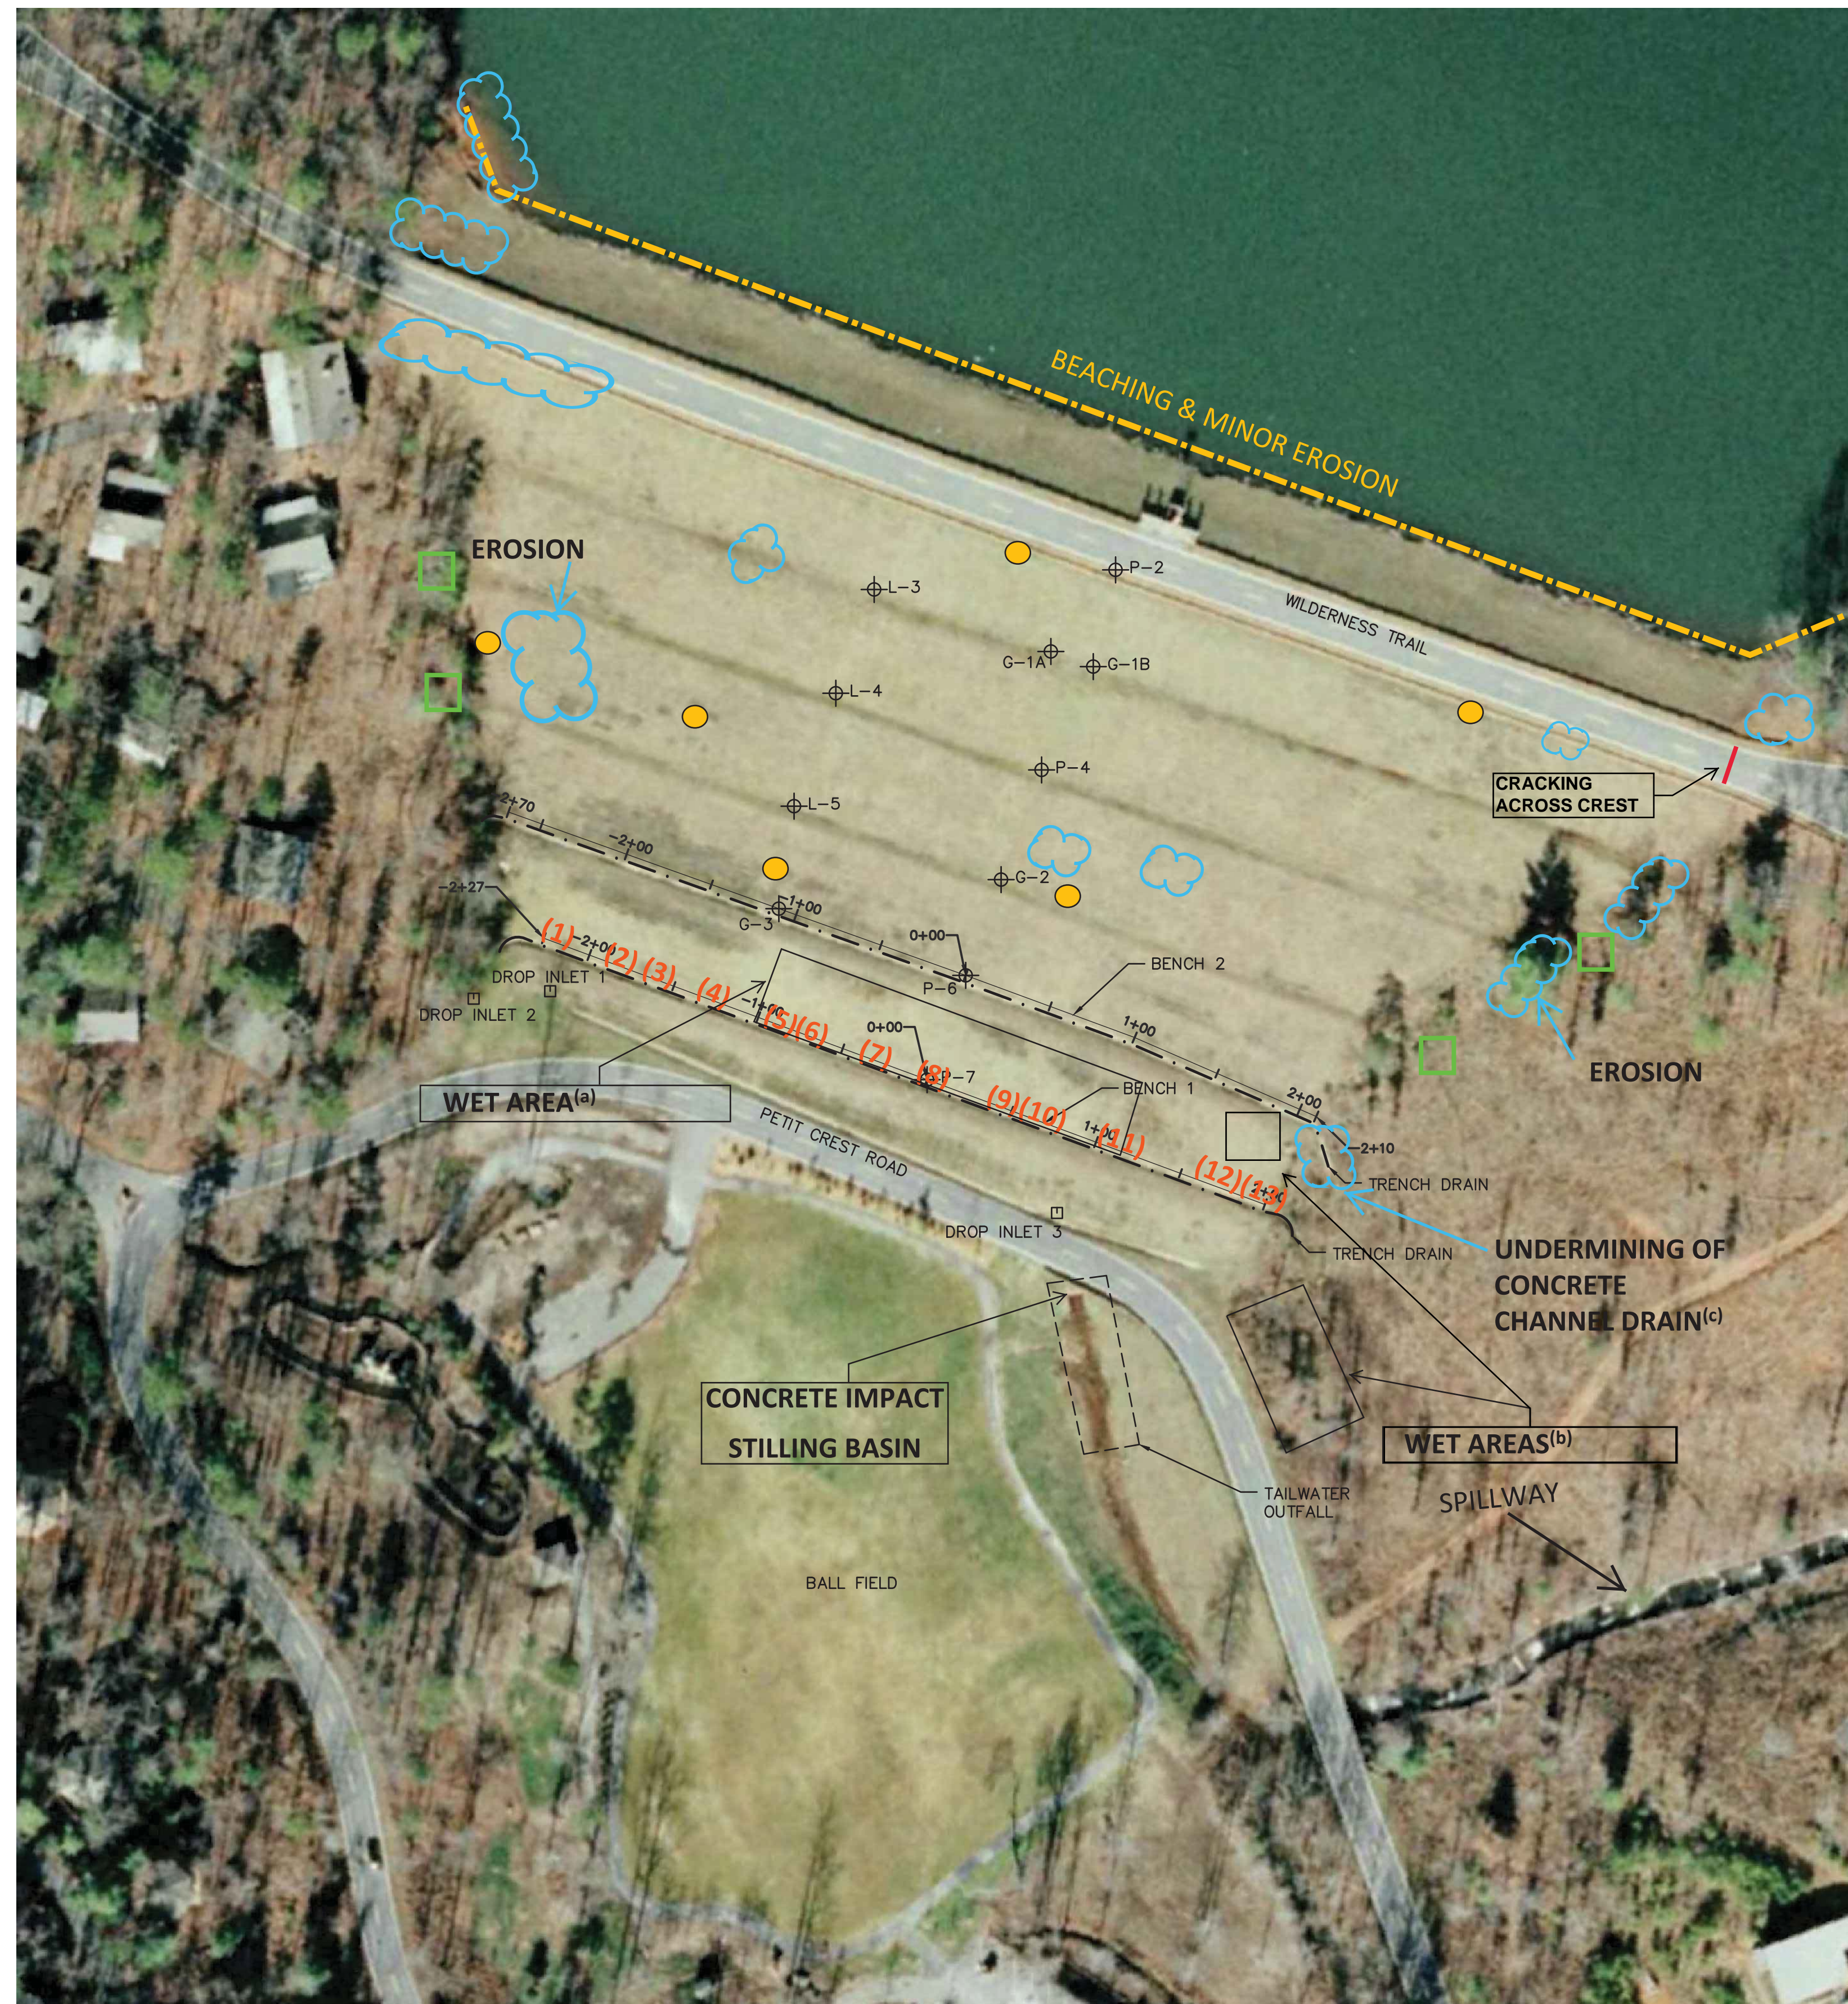
LEGEND	
	EXISTING PIEZOMETER
	DROP INLET / MANHOLE
	ANIMAL BURROW
	MINOR SURFACE EROSION (6- TO 12-IN. UNLESS OTHERWISE NOTED)
	INTERCEPTOR DRAIN
	DEBRIS

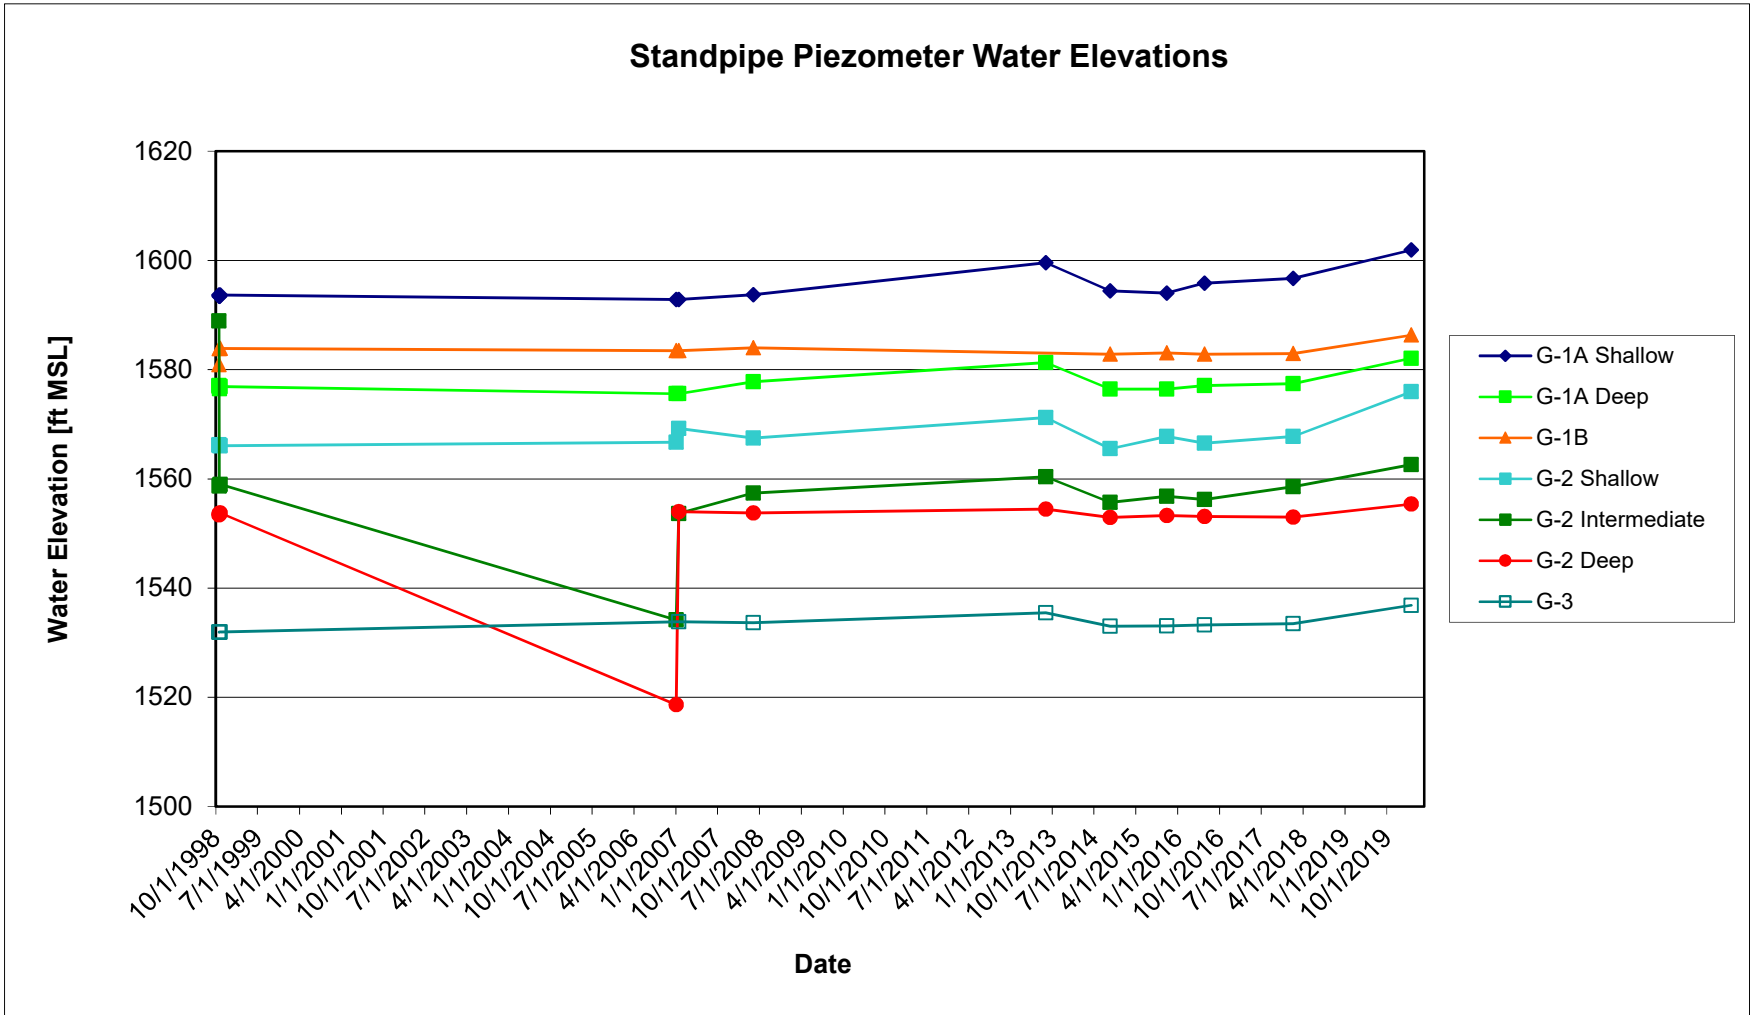
Note: G-2 Shallow water levels noted as anomolous on 3 Jan 2007. Re-measured 19 Jan 2007, and levels more consistent with previous readings.

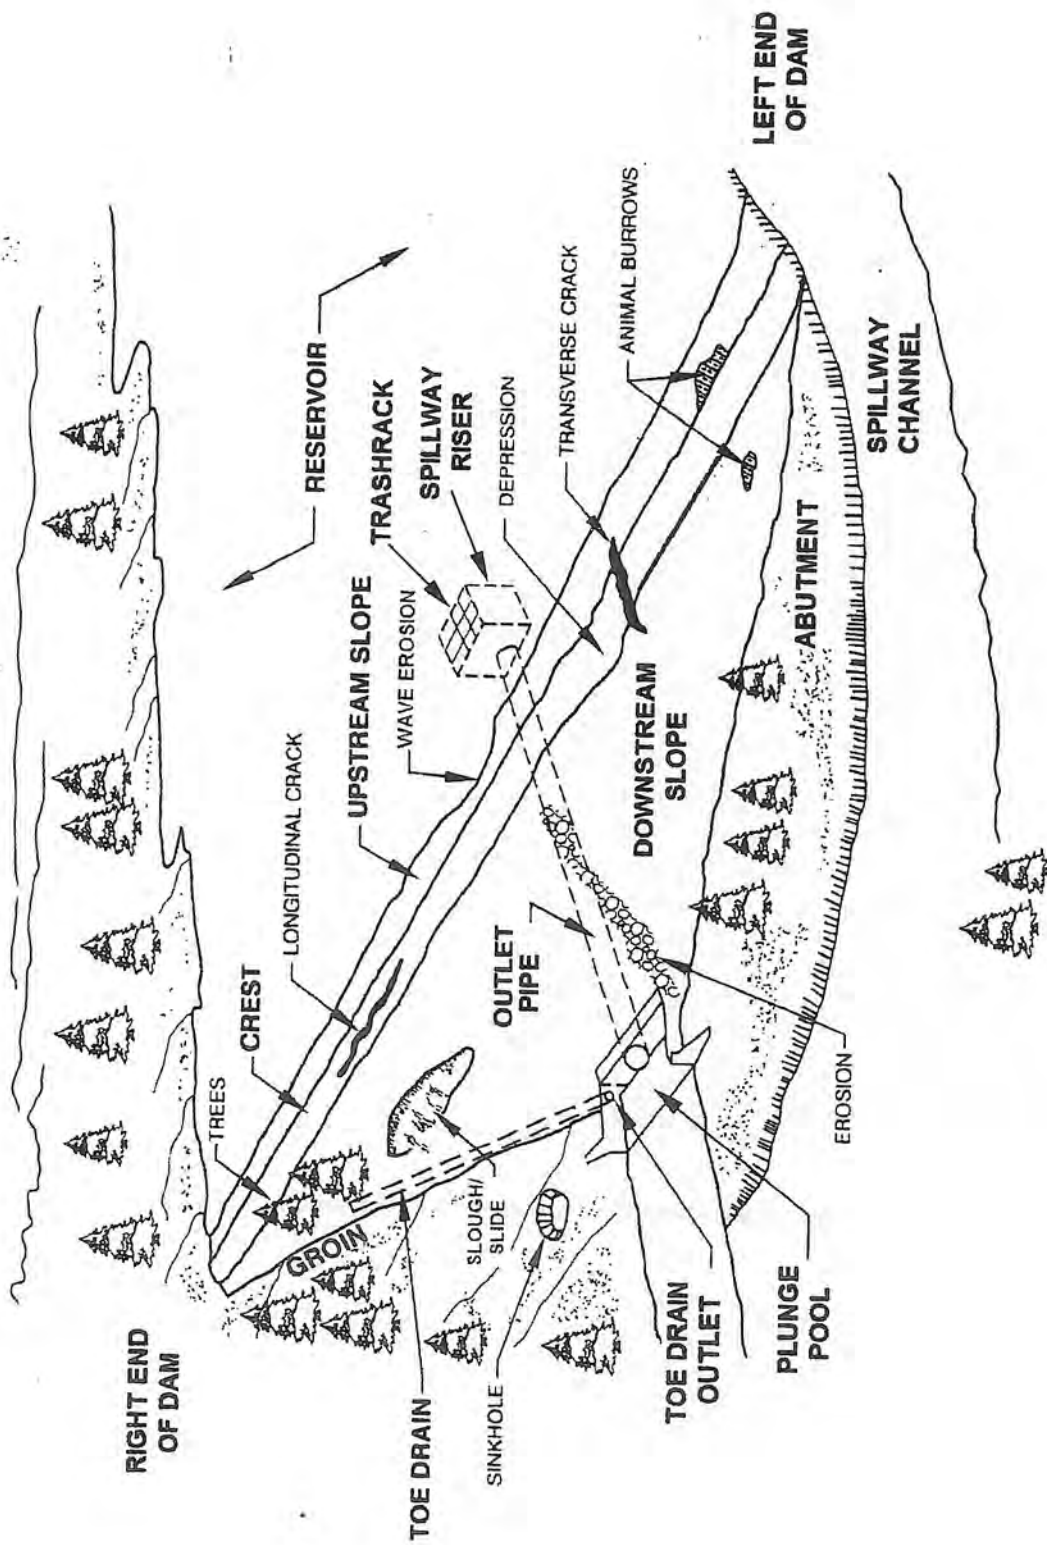
**TYPICAL EMBANKMENT DAM**  
 (COMMON DEFICIENCIES NOTED IN ORANGE)

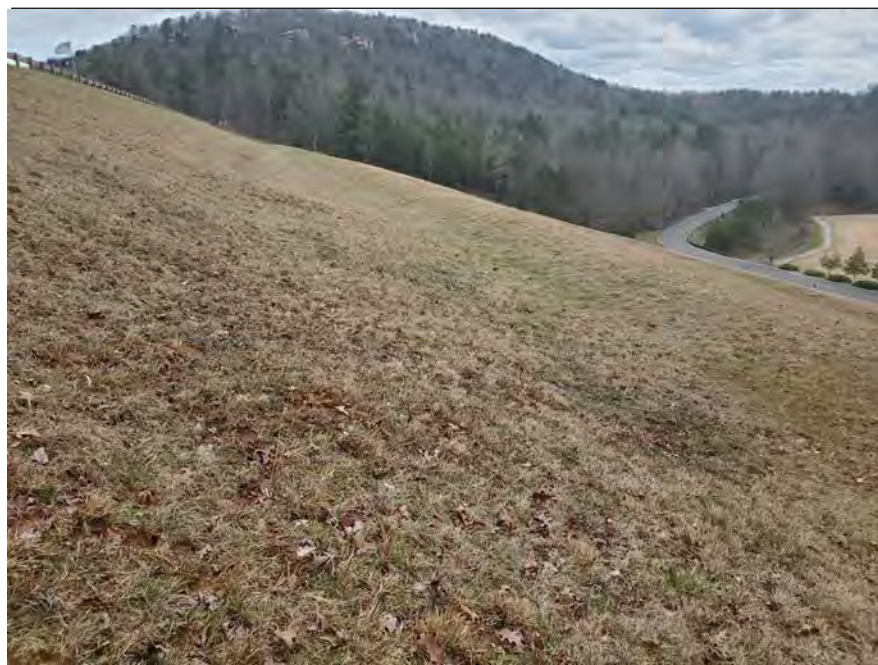
Photograph 10: Downstream Face, 2020 – general conditions as viewed from right abutment.

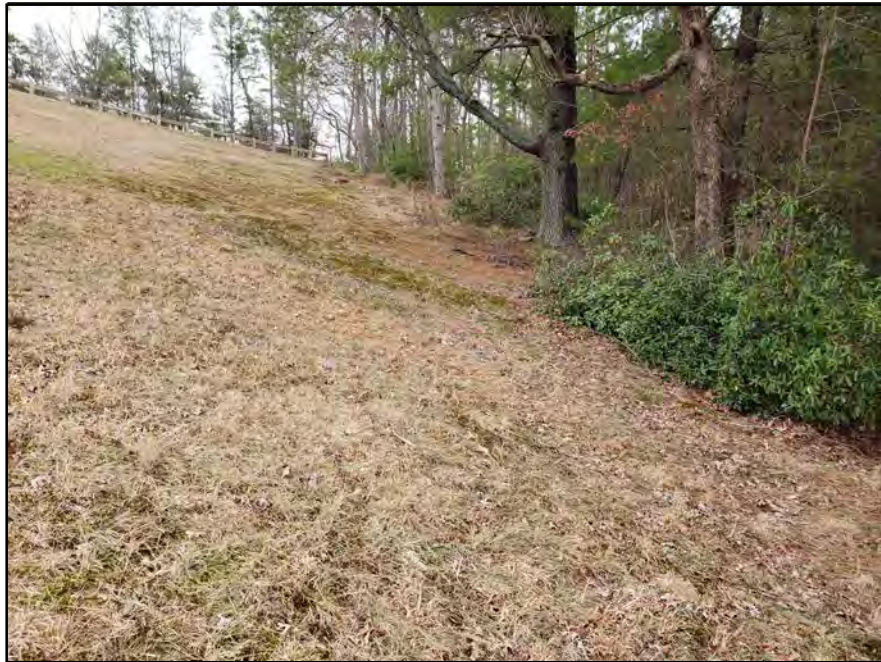
Photograph 11: Downstream Face, 2020 – typical surface erosion observed along the left abutment.

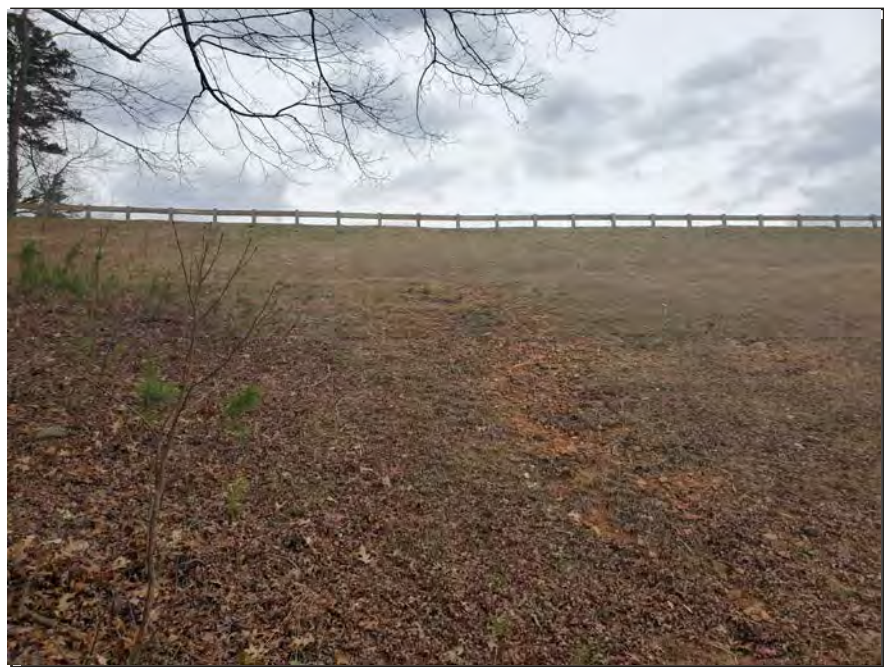
Photograph 12: Downstream Face, 2020 – surface erosion observed on the right abutment between benches.

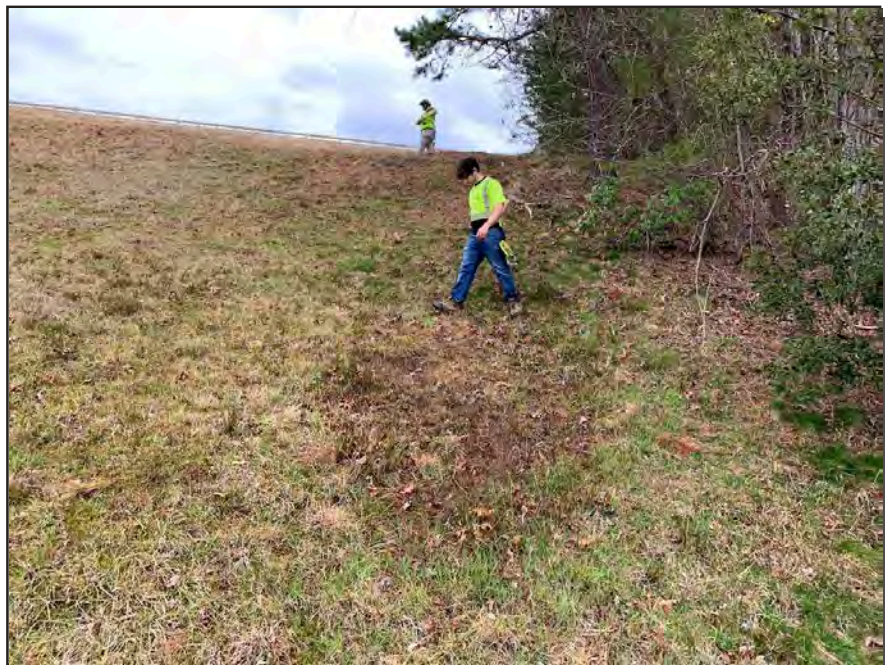
Photograph 18: Downstream Face, 2020 – wet surface area found between downstream benches.

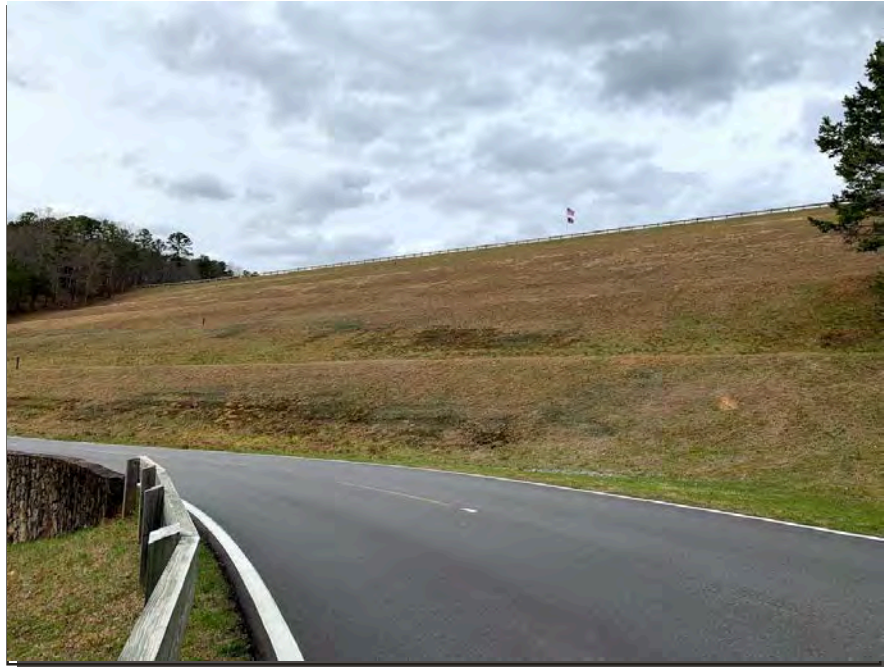
Photograph 21: Downstream Face, 2020 – overview of downstream face in good condition.

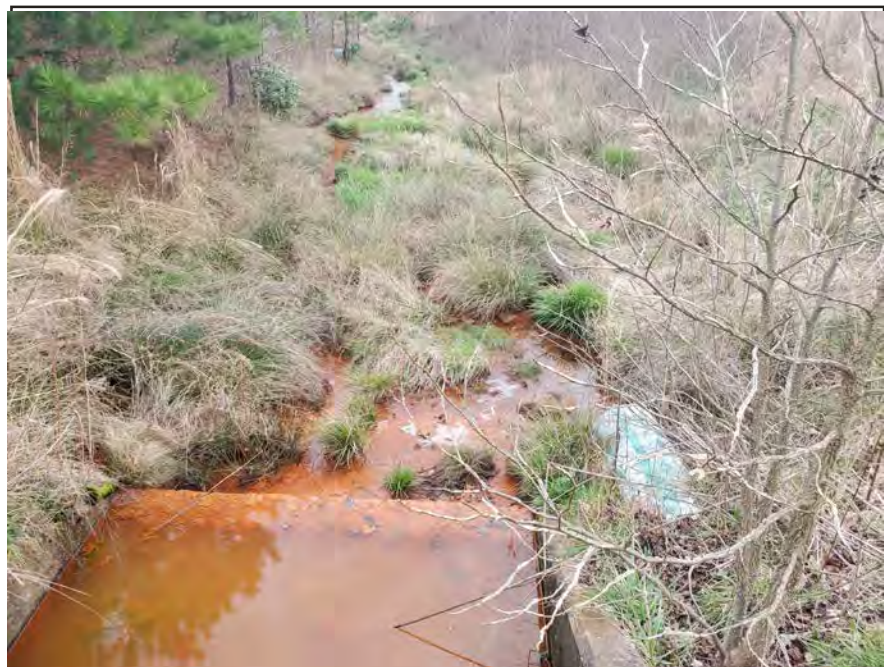
Photograph 22: Tail Water Creek, 2020 – view of the low-level outlet concrete stilling basin discharge to the tailwater creek.

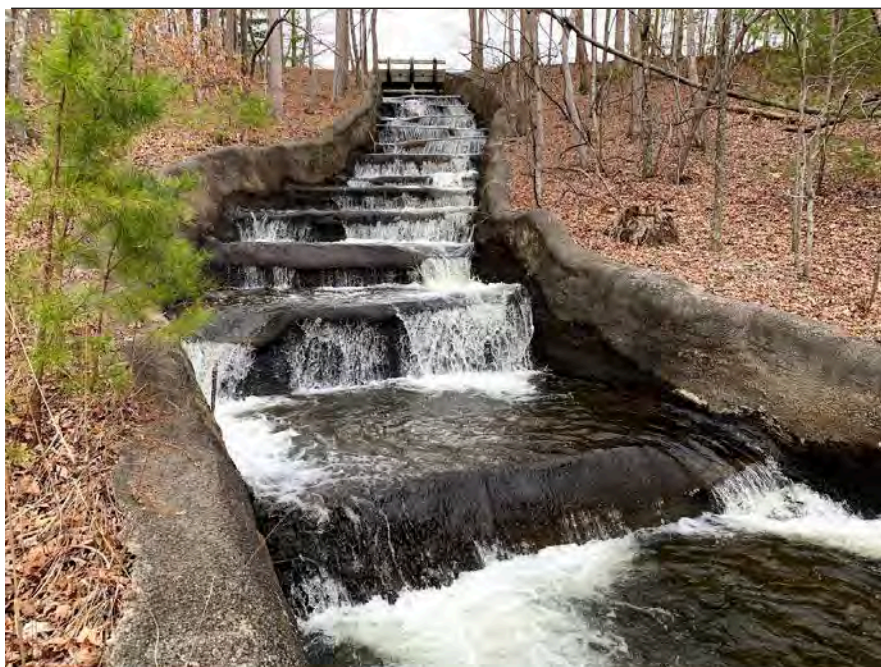
Photograph 24: Spillway, 2020 – general view of stepped spillway with moderate flow, and tree limbs and debris noted during inspection.

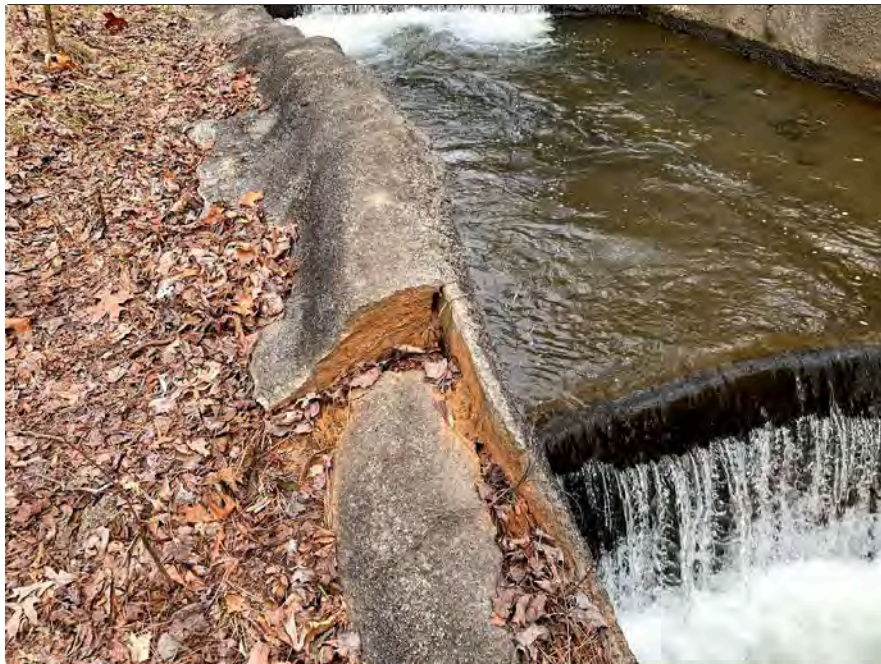
Photograph 25: Spillway, 2020 – general view of broken area on the side of the spillway with moderate flow during observation.

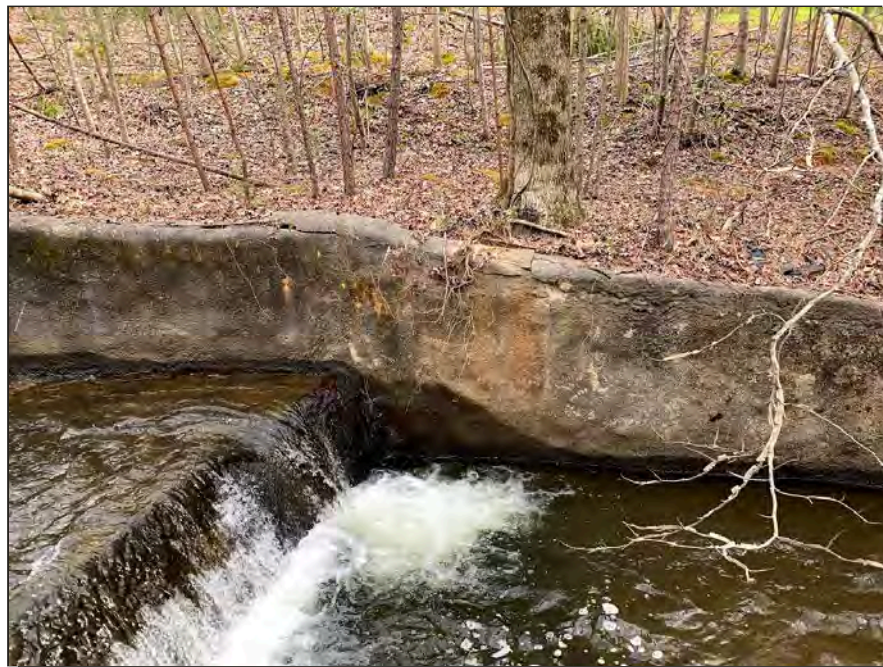
Photograph 26: Spillway, 2020 – general view of cracking on the sides of the spillway near tree roots.

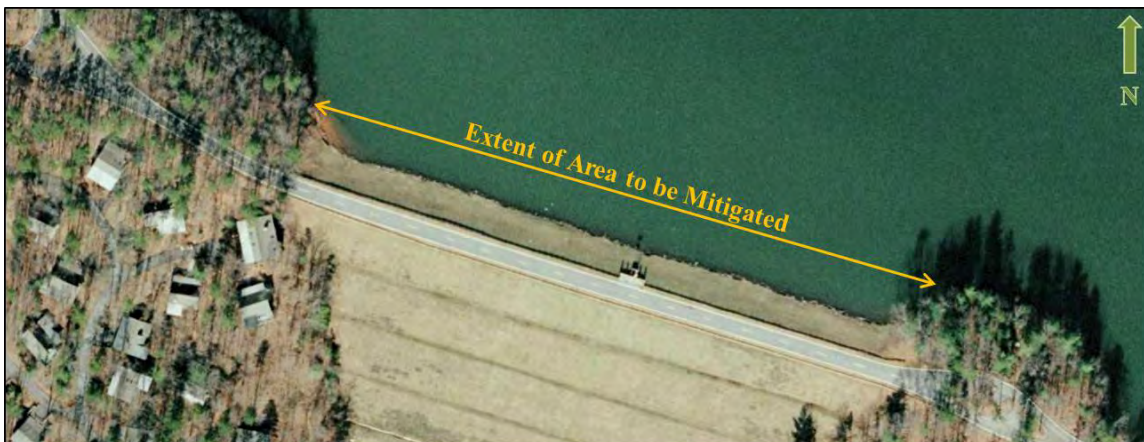
Figure 1: Lake Petit Dam extent of area where minor “beaching” erosion has been observed and is to be mitigated.

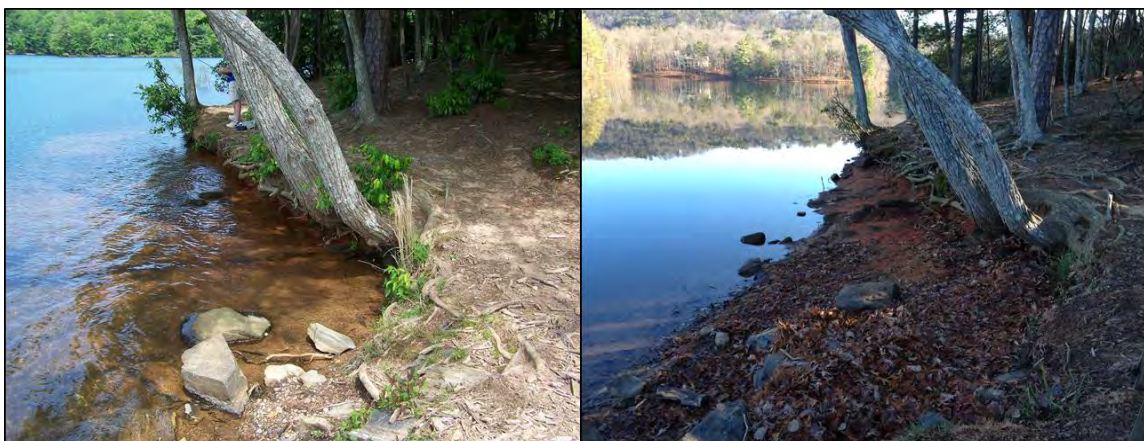
Figure 2: Looking east at minor “beaching” erosion at high lake level in 2008 (left) and low lake level in 2012 (right).
